# Use of a Resin-Modified Glass-Ionomer (RMGI) Liner in Conservative Direct Treatment of Deep Caries

John F. Weston, DDS

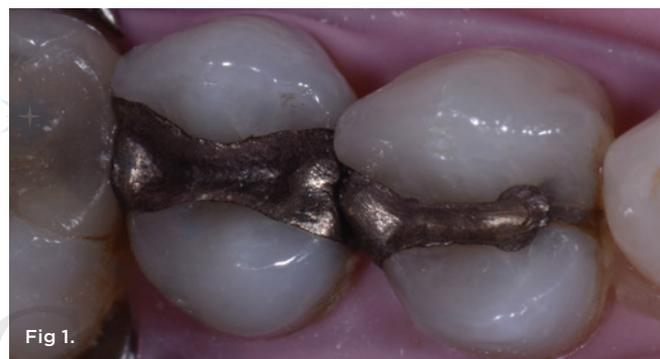
**Fig 1.** Preoperative condition of old amalgam restorations with gray staining and generalized microleakage. **Fig 2.** Preparations following removal of the amalgam. **Fig 3.** RMGI liner prepared for application.

The patient, a 52-year-old woman, presented with sensitive amalgam restorations on two premolars (Figure 1). She stated the amalgams had been placed when she was a teenager, and she reported sensitivity to cold on both teeth, as well as biting pain on the first premolar. Examination revealed a crack on the mesial aspect of the first premolar as well as gray staining and generalized microleakage around both restorations. While an indirect restoration may have been a possibility for the second premolar, it was determined that both teeth could be treated with direct restorations. The patient agreed to this course of treatment due to both time and cost advantages.

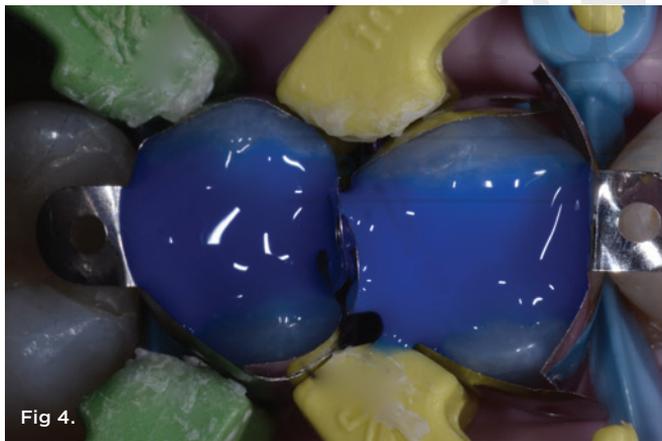
**Fig 4.** After the liner/base application, total etching was performed with 35% phosphoric acid. **Fig 5.** The preparations following etching of the RMGI liner, dentin, and enamel. **Fig 6.** Nanofilled flowable restorative in shade A3 opaque was placed on the dentin. **Fig 7.** A buccal wall increment of the packable restorative in an A1 body shade was placed. **Fig 8.** A lingual wall increment was then placed.

A matrix system (Triodent Sectional Matrix System, Triodent, www.triodent.com) was placed around the teeth, and total etching was performed with a 35% phosphoric acid solution (Ultra-Etch<sup>®</sup>,

Ultradent Products, Inc., www.ultradent.com) (Figure 4). Universal adhesive (Scotchbond™ Universal Adhesive, 3M ESPE) was scrubbed into the preparations for 20 seconds, and excess adhesive was removed with a dry microtip. The preparations were then air-dried for 15 seconds until there was no movement of the adhesive, and the teeth were light-cured for 10 seconds (Figure 5).

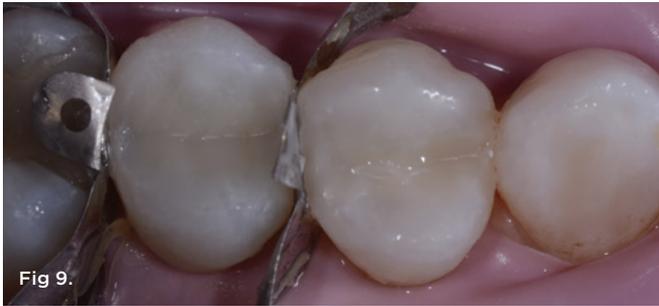
Fig 9.

**Fig 9.** A matrix band was left in place for initial contouring. **Fig 10.** The restorations are shown following completion of contouring. **Fig 11.** Finishing and polishing first with beige spiral wheel. **Fig 12.** Final polishing was done with white spiral wheel. **Fig 13.** Final result.

To begin basic contouring, the matrix rings and wedges were removed but bands were left in place to protect the adjacent teeth (Figure 9). The bands were removed after basic contouring (Figure 10). The rubber dam was then removed, and the occlusion was checked. Final finishing and polishing was completed with finishing and polishing wheels (Sof-Lex™, 3M ESPE), progressing from beige to white (Figure 11 and Figure 12).
